## UNITED STATES ARMY

*Redstone Technical Test Center*

**SUBJECT:** Letter Report for Insuladd's Use on Multiple Launch Rocket System (MLRS)  
M270 Launcher Solar Radiation Test

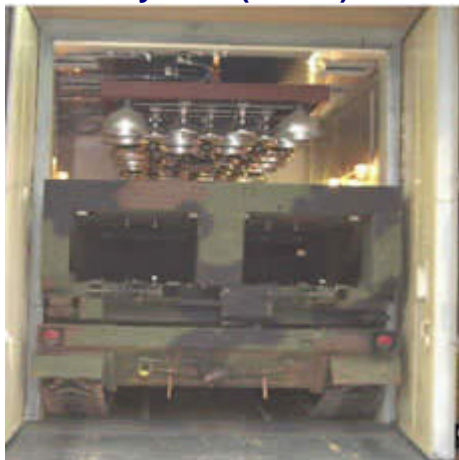
## Multiple Launch Rocket System (MLRS)

**M270 Launcher Solar Radiation Test**

3. The launcher is too large for this chamber to conduct a standard MIL-STD-810 solar radiation test. However the objective was to determine the effectiveness of the paint additive on the cab area. To accomplish the objective two launchers were subjected to identical solar loading over a two day period. Launcher, S/N 4AA00481, had been painted using Insuladd and launcher, S/N 4AA00222, was not.
